Lower Colorado River Multi-Species Conservation Program

Hart Mine Marsh

2018 Annual Report

October 2019

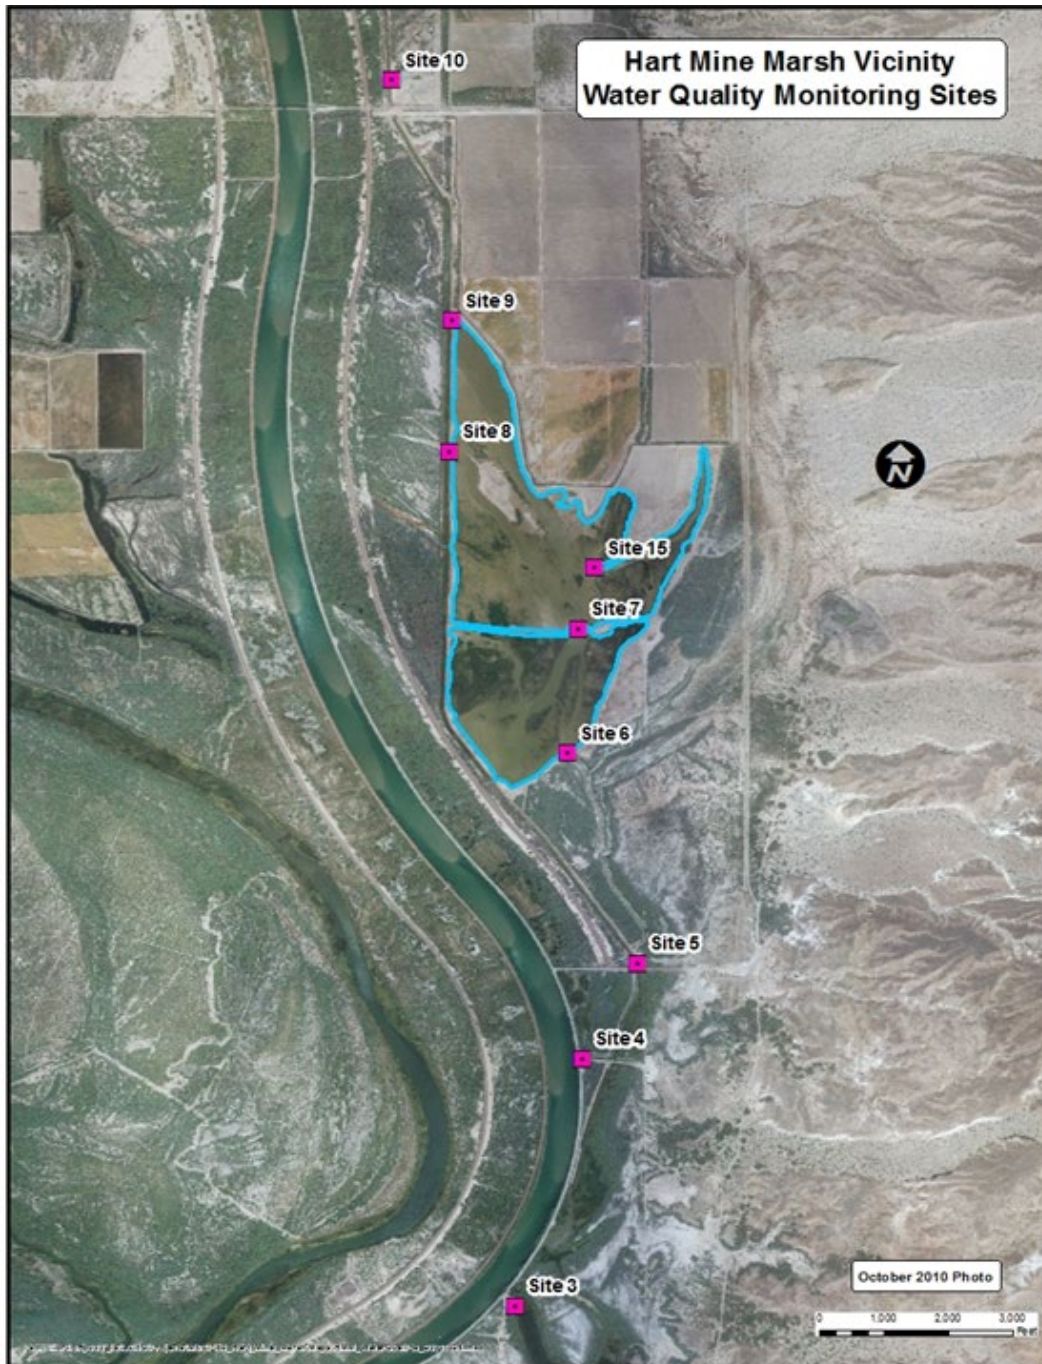
Figure 3.—HMM water quality monitoring locations.

The USFWS was responsible for monitoring and reporting on many abiotic parameters of the site as part of the interagency agreement with Reclamation. Cibola NWR staff continued monthly water quality monitoring at specific points throughout the marsh. Water quality parameters including pH, dissolved oxygen, and specific conductivity (as a measurement of total salinity) were measured throughout the FY. Figure 3 shows the locations (sites) where water quality parameters are measured and collected.
